NBSIR 83-2774 (NTSB) (R)

**Examination of Failed Tension-Torsion Strap
from Bell 206B, N90071, Helicopter**

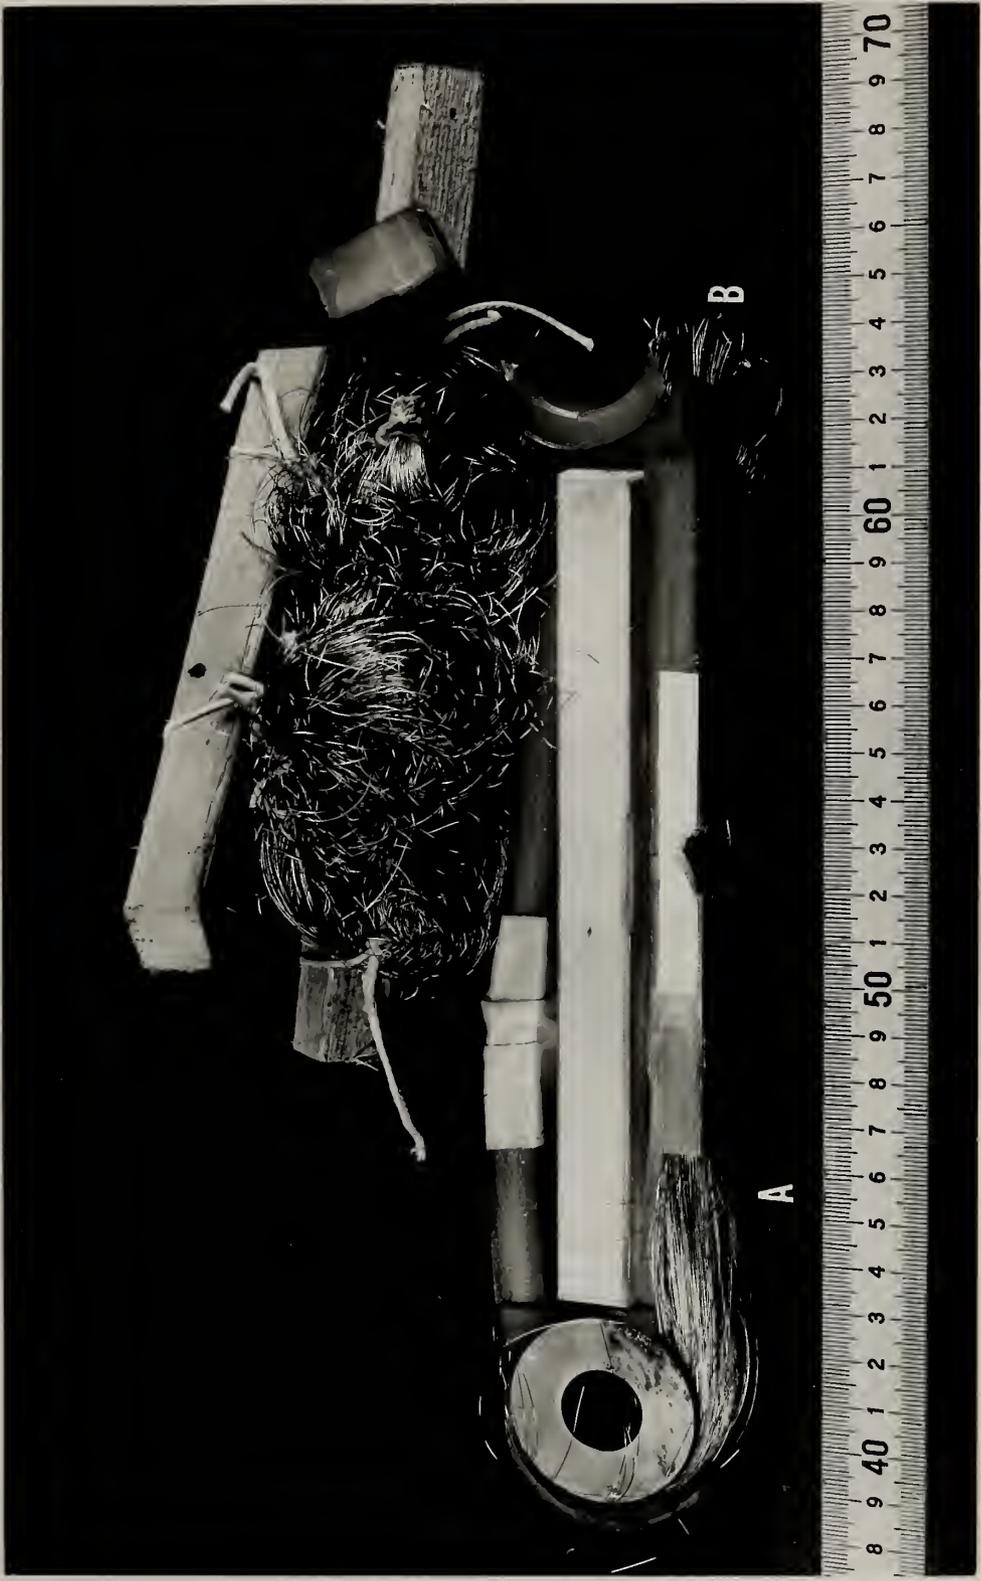
Figure 1. Failed tension-torsion strap with the fractured wires as-received at NBS. The letters A and B indicate locations where wire fracture samples were taken for examination.
X 3/5

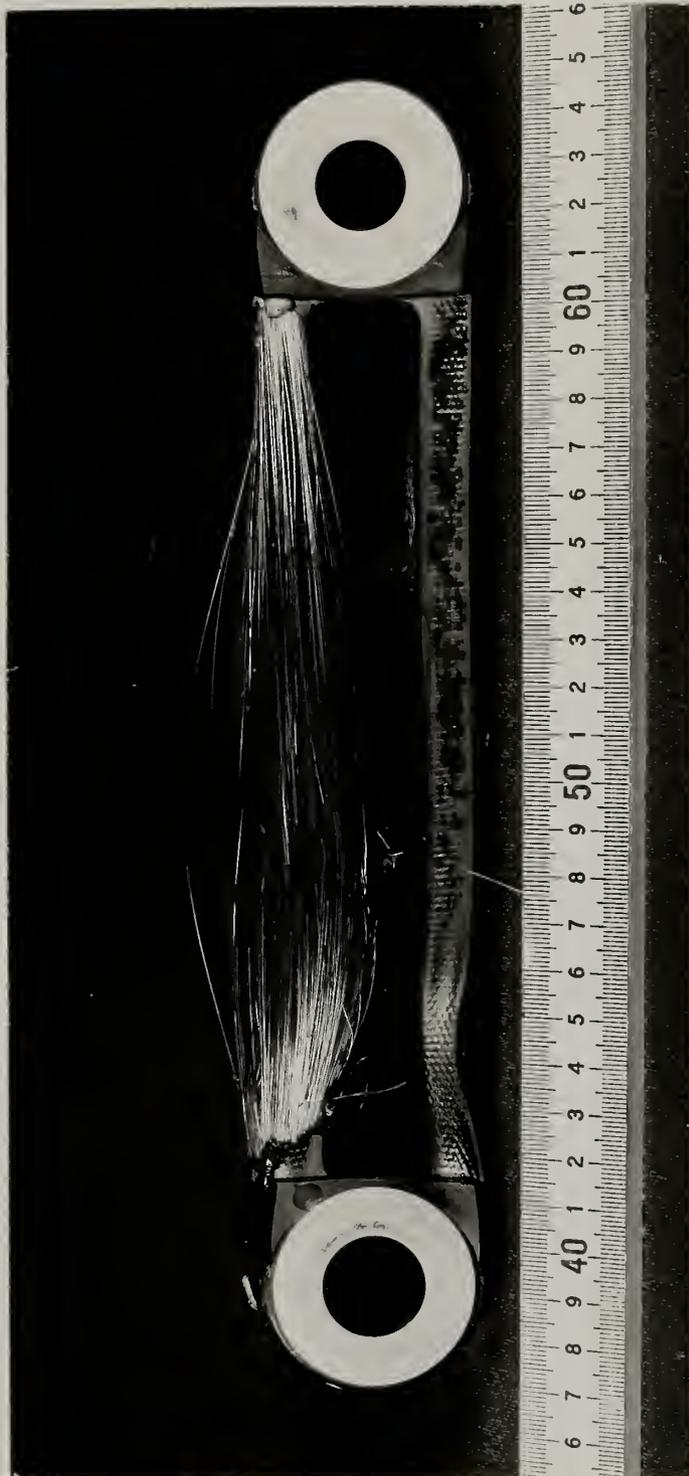
Figure 2. Tension-torsion strap with the wires essentially intact, as-received at NBS. Much of the polyurethane molding has been removed. X 3/5

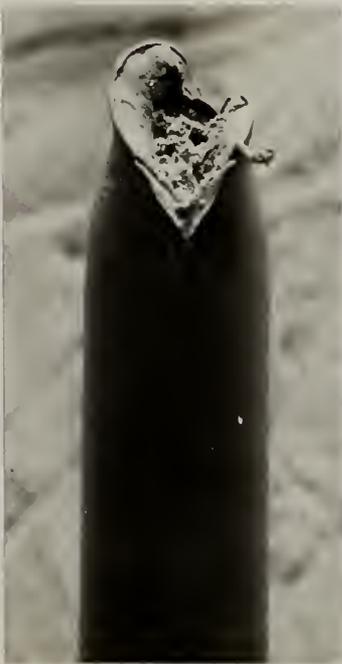
Figure 3. Wire no. 4-13, location A. This fracture was produced in the NBS laboratory by pulling the wire in tension. The fracture is a cup-cone type with significant necking. The primary fracture mode is dimpled rupture.

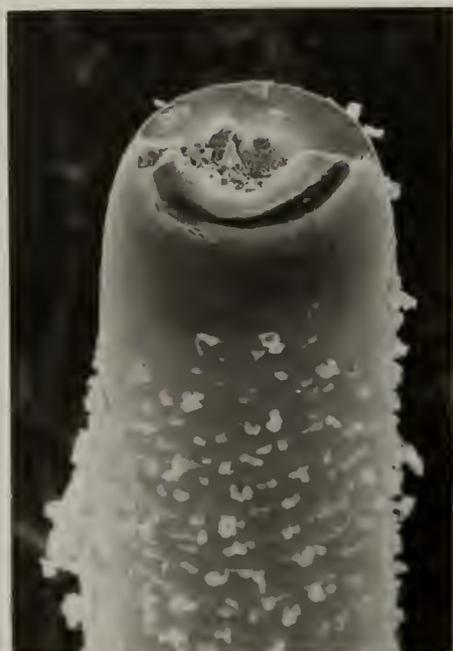
Figure 5. Wire no. 4-6, location A, cleaned in petroleum ether. The fracture is primarily cup-cone with considerable necking. There is a significant transverse component. The predominant fracture mode is dimpled rupture.

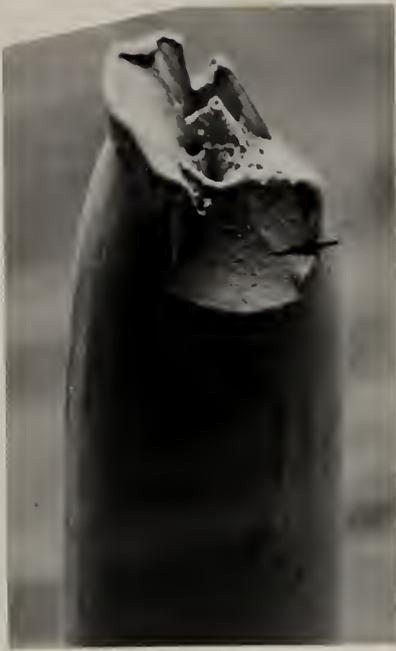
Figure 6. Wire no. 2-2, location B, cleaned ultrasonically in (1) petroleum ether, (2) amyl acetate, (3) commercial paint remover followed by rinsing in petroleum ether. The fracture appears to be basically cup-cone with some necking. Dimpled rupture is the predominant fracture mode. There is a considerable amount of foreign material adhering to the surface of the wire.

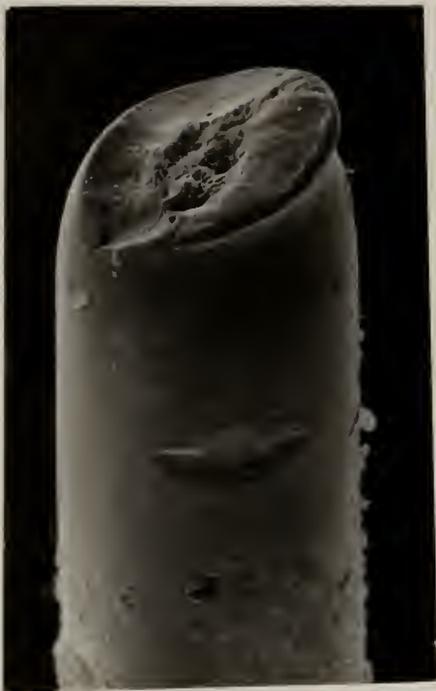
Figure 7. Wire no. 1-2, location B, cleaned ultrasonically in (1) petroleum ether, (2) amyl acetate, (3) commercial paint remover followed by rinsing in petroleum ether. The fracture is basically cup-cone with significant necking. Dimpled rupture is the predominant fracture mode. The fractograph shown in figure 7c was taken in the area indicated by the arrow in 7a. There appear to be imperfections or mechanical damage in the coating or surface of the wire as can be seen in figure 7a.

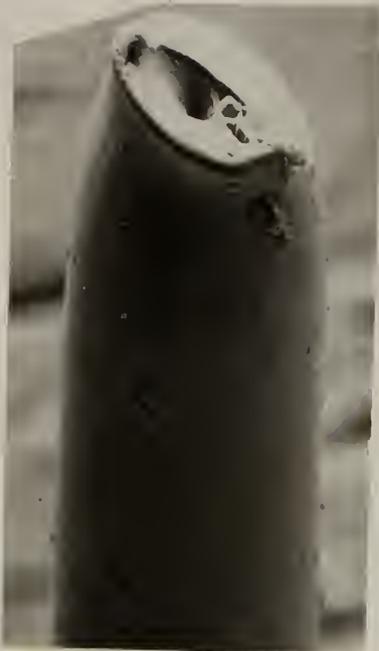
Figure 8. Wire no. 2-3, location B, cleaned by soaking in a commercial polyurethane solvent followed by rinsing in petroleum ether. The fracture is basically cup-cone. Some necking is evident. What appears to be the polyurethane batter used to coat the wire is covering part of the fracture adjacent to the wire surface (figure 8b). The fractograph shown in figure 8c was taken near the center of the fracture. There appears to be foreign material on the fracture surface and the fracture mode is unclear.

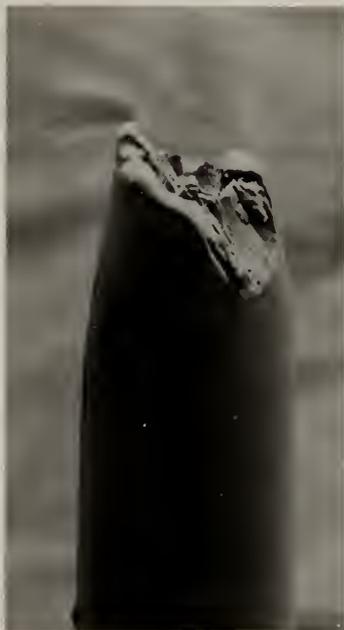
Figure 9. Wire no. 1-6, location B, cleaned ultrasonically in petroleum ether. The fracture appears to be primarily cup-cone with considerable necking. Dimpled rupture is the predominant fracture mode.

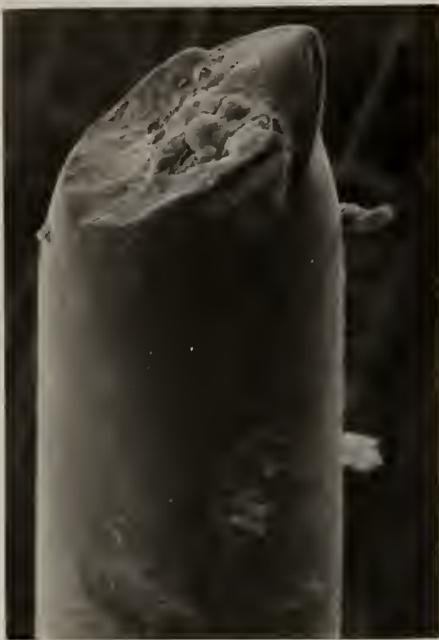
Figure 10. Wire no. 1-5, location B, cleaned ultrasonically in (1) petroleum ether, (2) amyl acetate, (3) commercial paint remover followed by rinsing in petroleum ether. The fracture appears to be primarily cup-cone with significant necking adjacent to the fracture. The primary fracture mode is dimpled rupture.

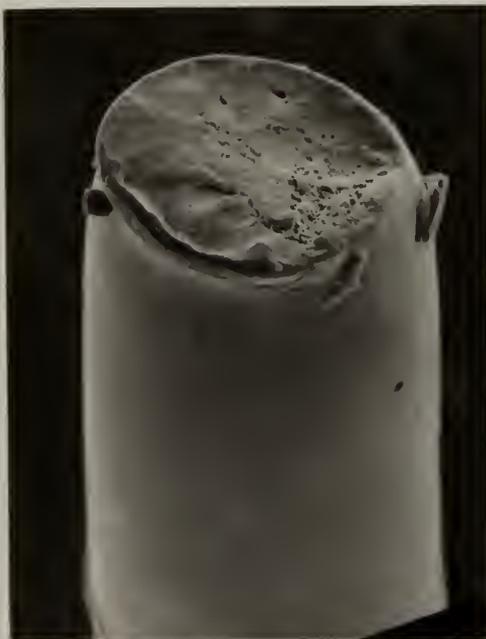
Figure 11. Wire no. 2-4, location B, cleaned by soaking in a commercial polyurethane solvent followed by rinsing in petroleum ether. The fracture appears to be a combination of cup-cone and shear with significant necking. The predominant fracture mode is dimpled rupture. There is a considerable amount of debris on both the fracture surface and on the surface of the wire.

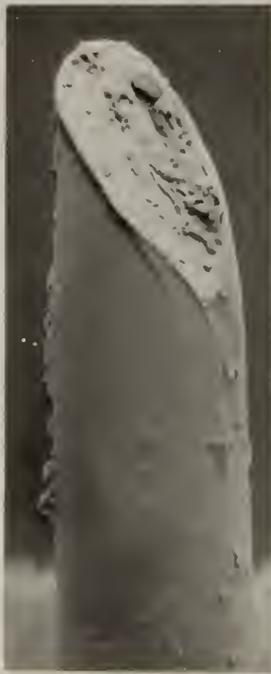
Figure 12. Wire no. 2-1, location B, cleaned by soaking in a commercial polyurethane solvent followed by rinsing in petroleum ether. The fracture is relatively flat and is about 90° to the longitudinal axis of the wire. There are numerous small holes in the fracture surface. The fractograph shown in figure 12b was taken at the lower right of the fracture as shown in figure 12a where the concentration of holes appeared to be greatest. There is very little necking and the fracture mode is unclear.

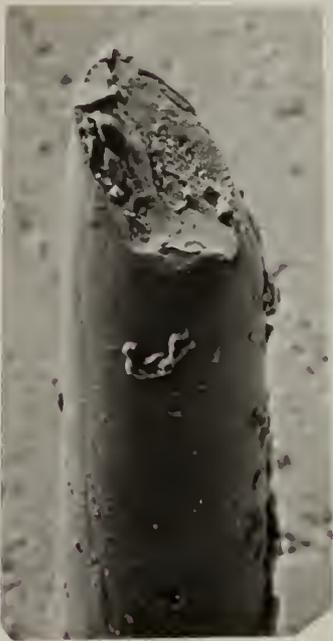
Figure 13. Wire no. 3-5, location B, cleaned by soaking in a commercial polyurethane solvent followed by rinsing in ethanol. Apparent shear fracture with small amount of necking. The fracture mode is unclear, but the necking indicates some ductility. There is considerable debris on both the fracture surface and on the surface of the wire.

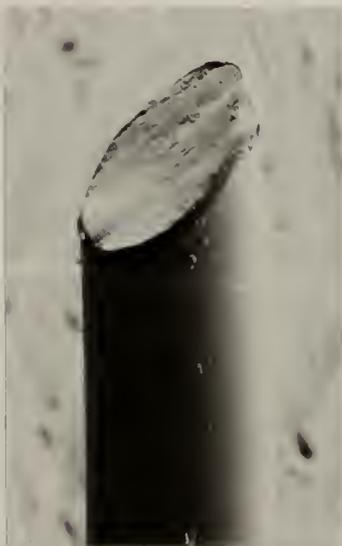
Figure 15. Wire no. 2-5, location B, cleaned by soaking in a commercial polyurethane solvent followed by rinsing in petroleum ether. The fracture is primarily shear with a small amount of necking. The predominant fracture mode is dimpled rupture. There is a considerable amount of debris on both the fracture surface and the surface of the wire.

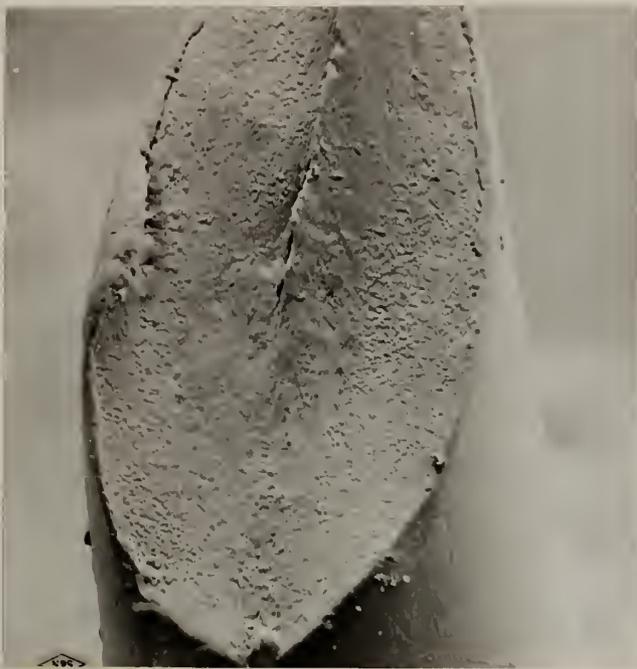
Figure 16. Wire no. 1-1, location B, cleaned ultrasonically in (1) petroleum ether, (2) amyl acetate, (3) commercial paint remover followed by rinsing in petroleum ether. Shear fracture with little or no necking. The fracture mode is unclear, although there is some evidence to indicate dimpled rupture.

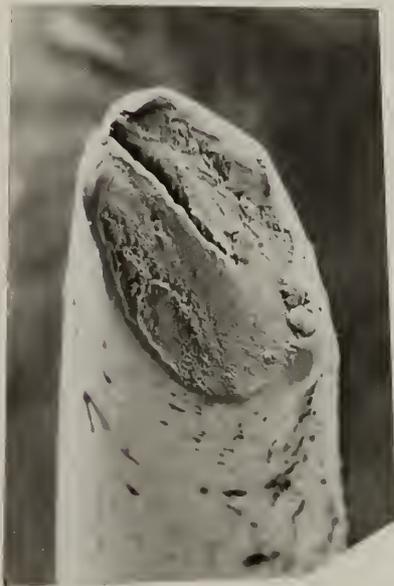
Figure 17. Wire no. 1-3, location B, cleaned ultrasonically in (1) petroleum ether, (2) amyl acetate, (3) commercial paint remover followed by rinsing in petroleum ether. The shear fracture follows two different planes over about the upper 2/3 of figure 15a. There is a longitudinal crack intersecting the fracture at the dividing line between the two fracture planes. The fracture mode is unclear, but there is some evidence of striations.

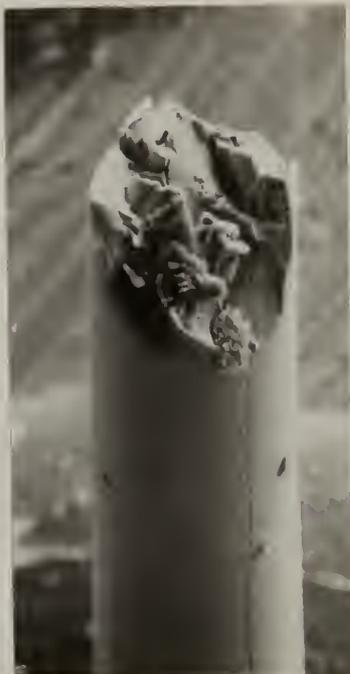
Figure 19. Wire no. 1-10, location B, cleaned ultrasonically in (1) petroleum ether, (2) amyl acetate, (3) commercial paint remover followed by rinsing in petroleum ether. This is an apparent shear fracture with a small amount of necking. The predominant fracture mode is dimpled rupture.

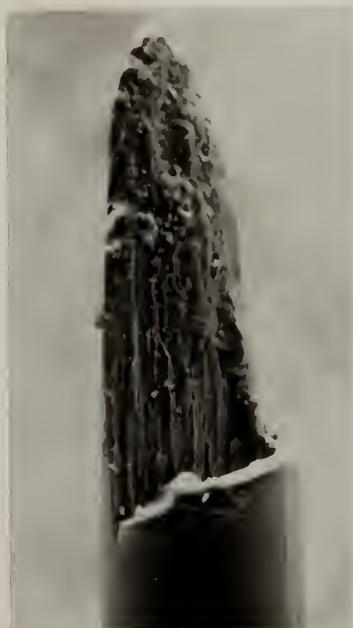
Figure 21. Wire no. 4-5, location A, cleaned in petroleum ether. The fracture appears to be a combination of cup-cone and shear with some necking. The predominant fracture mode is dimpled rupture, although there is evidence of striations. Some of the apparent striations are actually elongated dimples.

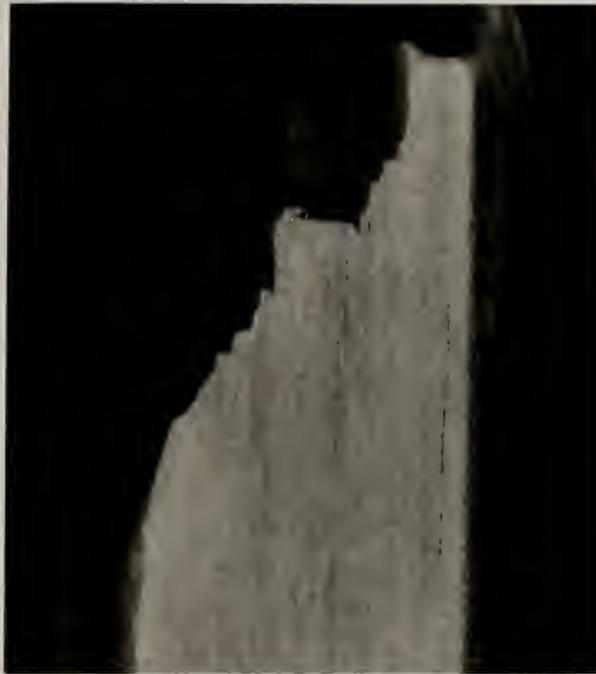
Figure 26. Longitudinal section through wire shown in figure 23 exhibiting the fracture profile. The longitudinal axis of the wire is vertical.
Etchant: 4% picral + 1% HCL X 500

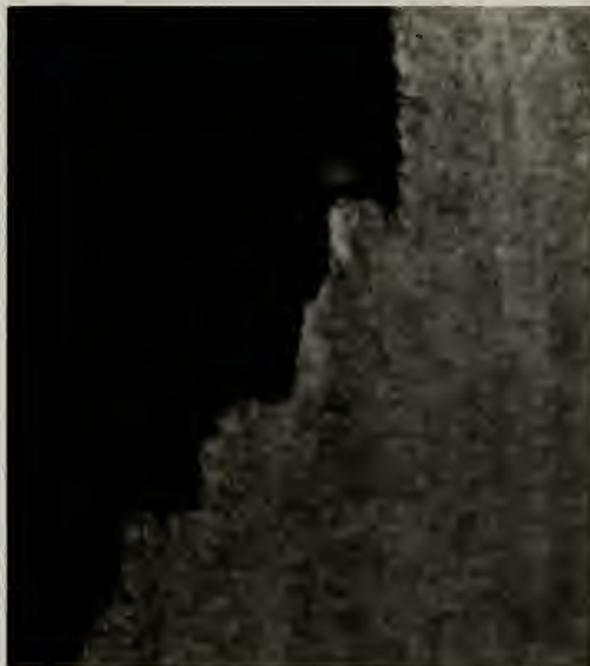
Figure 27. Part of the field shown in figure 26 above, but at higher magnification.
Etchant: 4% picral + 1% HCL X 2500
